## Concrete Supply Company – Mauldin Plant

### Unpermitted Industrial Stormwater Inspection SC

December 11, 2018

SW-CSCMauldin-12/11/18

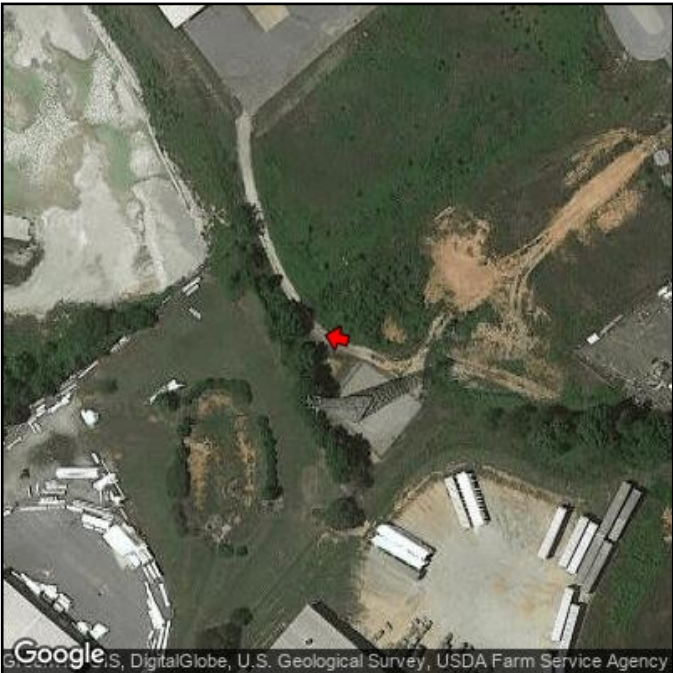
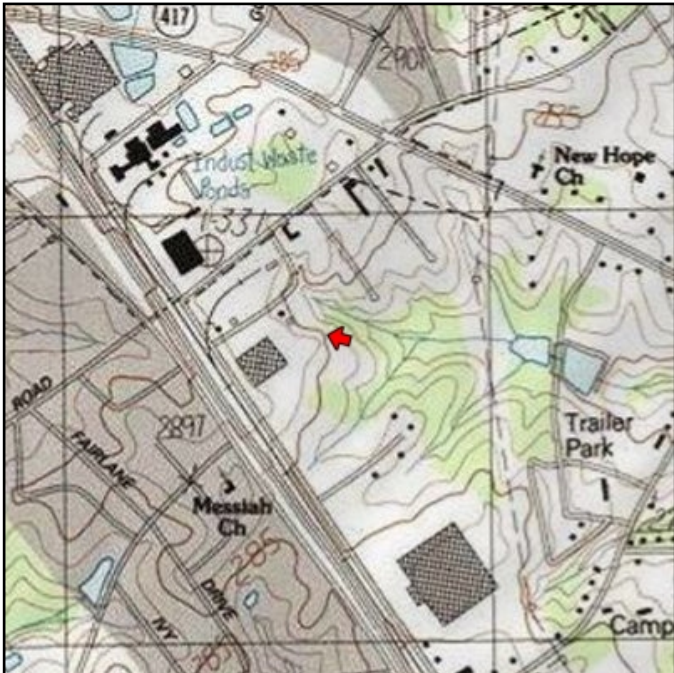
Attributes	
Description	Stormwater conveyance behind recycled concrete area berm.

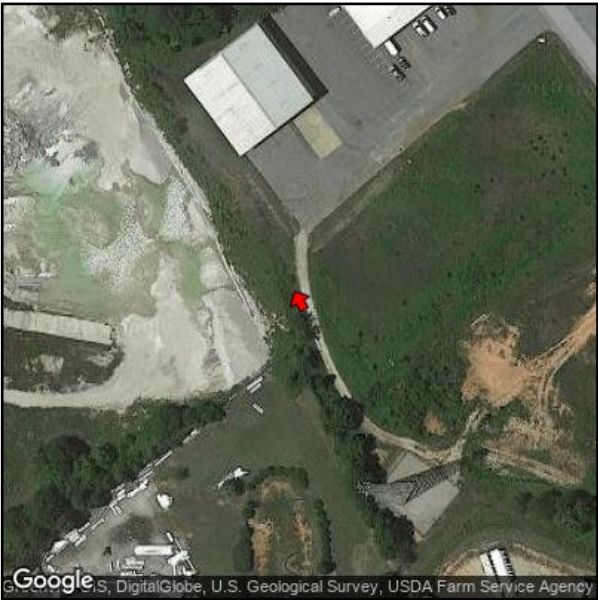
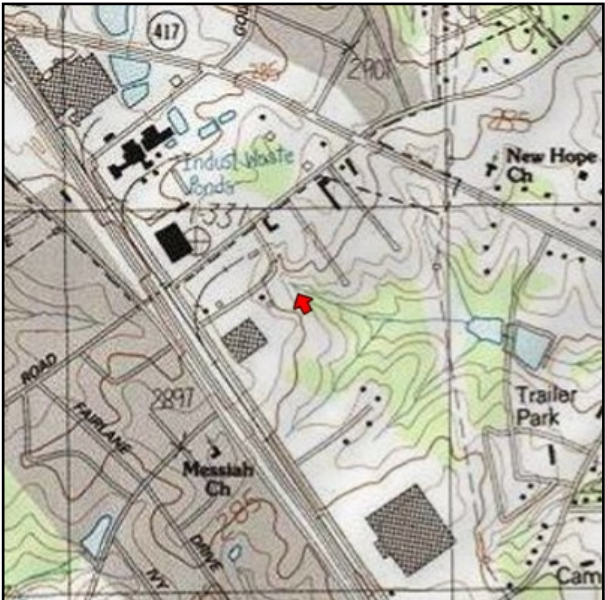
Attributes	
Description	In the foreground is the inlet side of a pipe under the access road. It receives water from the northwestern side of the facility, including from the outlet area of Outfall #3 and the seeps from the berm around the concrete recycling area.

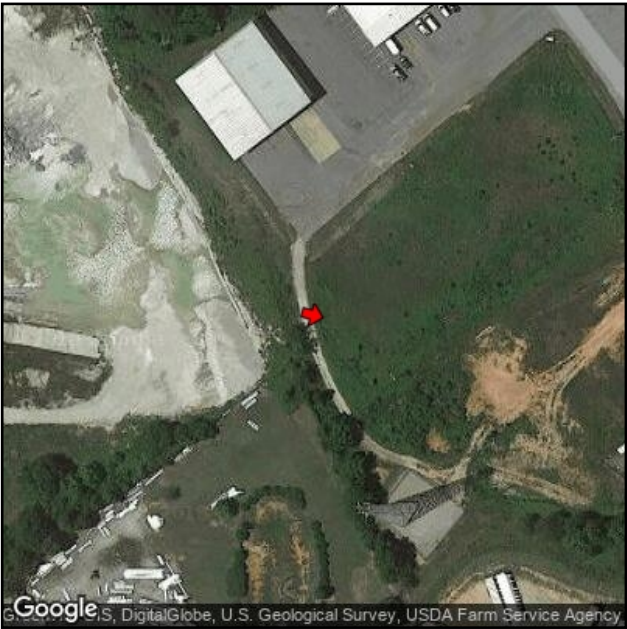
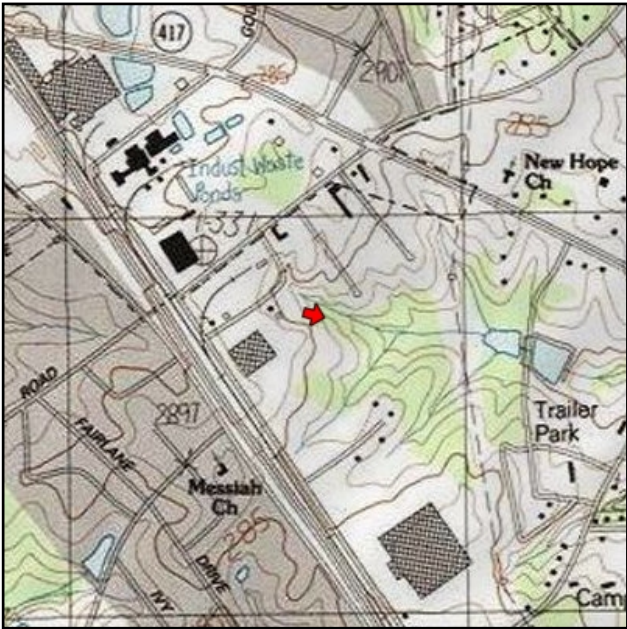
Attributes	
Description	Outlet side of the pipe under the road that handles runoff from this side of the site. This conveyance is next to the cell tower access road. Water was observed flowing through this conveyance.

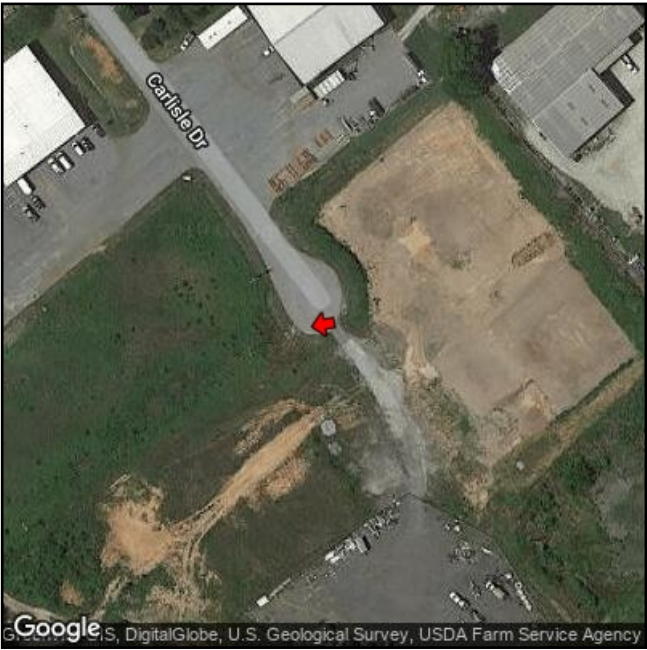
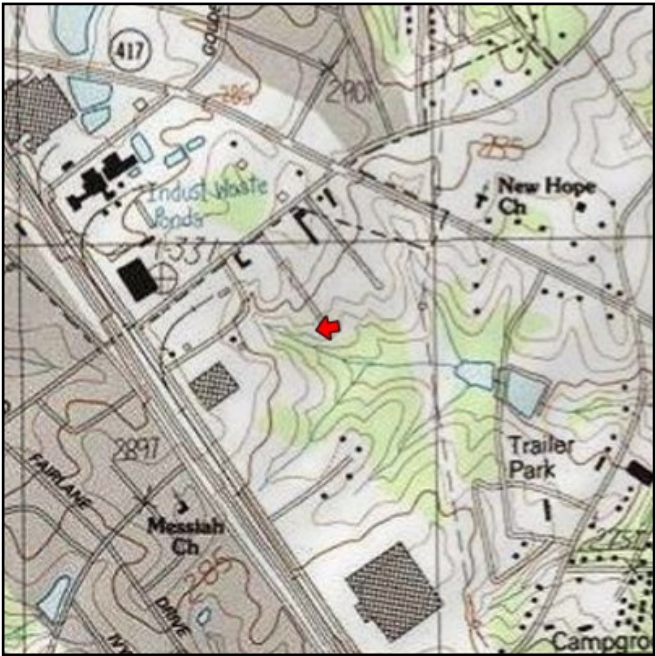
Attributes	
Description	Drop inlet downgradient from the pipe in photos DSCN1532 and DSCN1533.
